# Qualified Inspection & Maintenance Workshop

City of Chattanooga

Development Resource Center

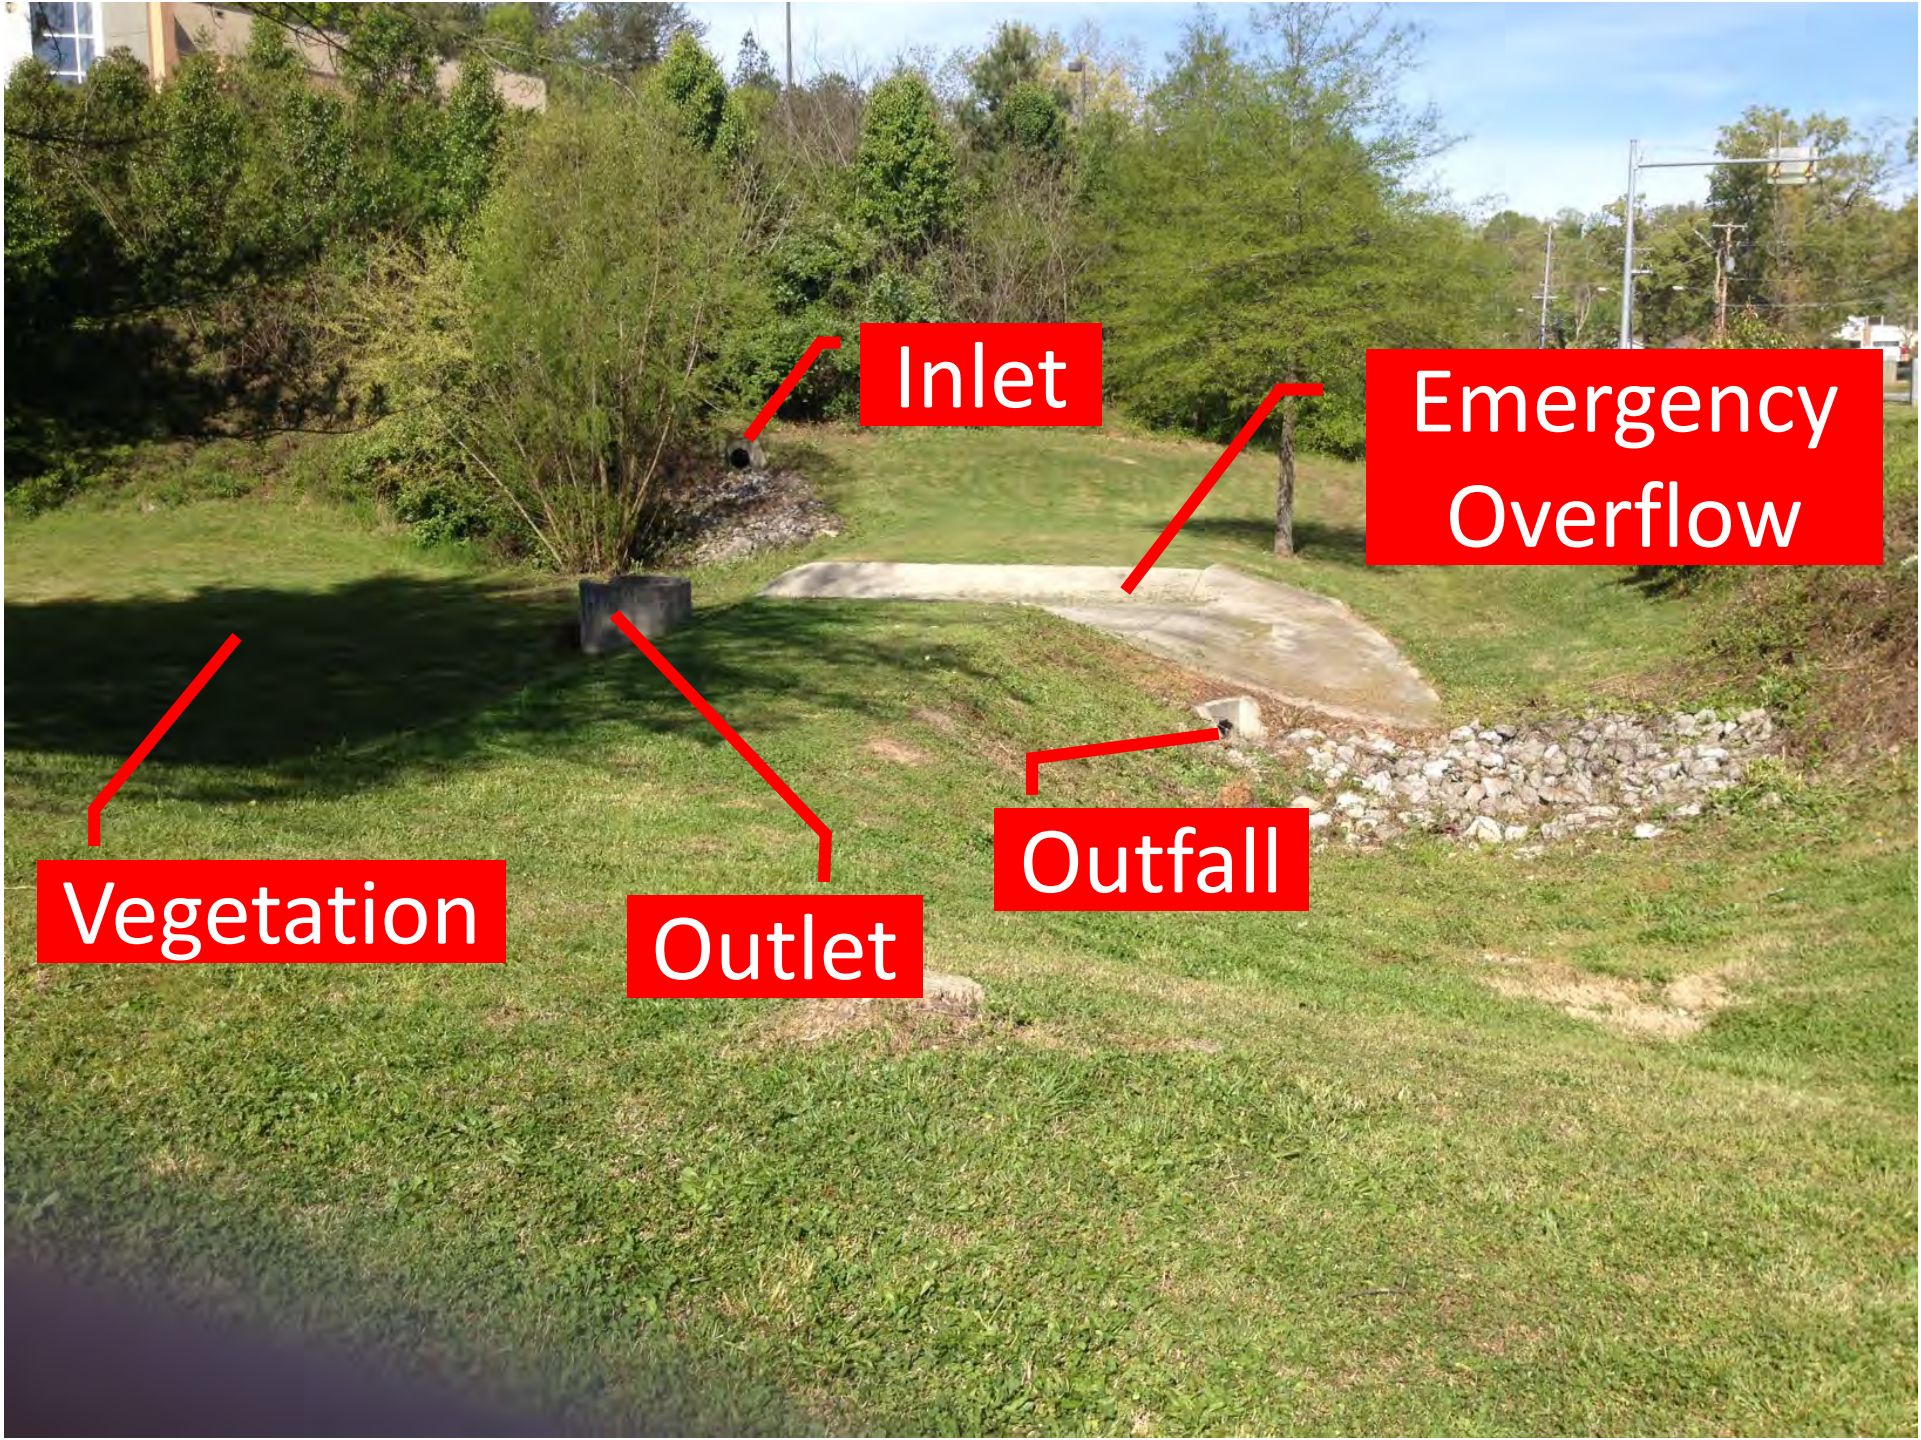
Inlet

Emergency  
Overflow

Vegetation

Outlet

Outfall

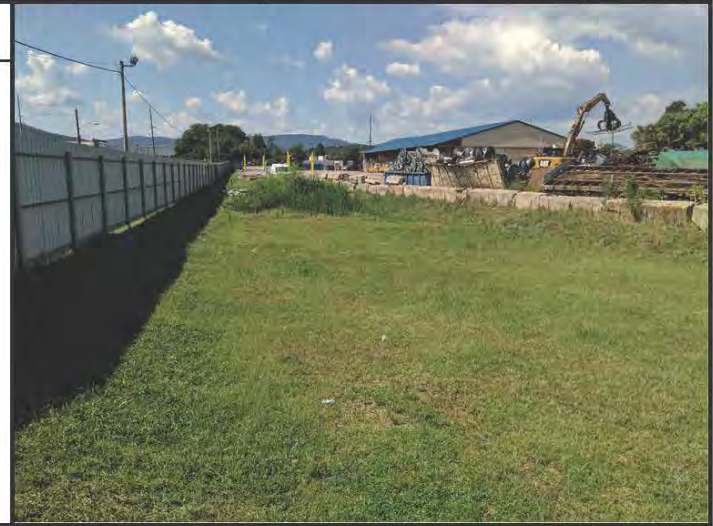
Photo No. 5	Date: 9/19/18
Description: View of Basin

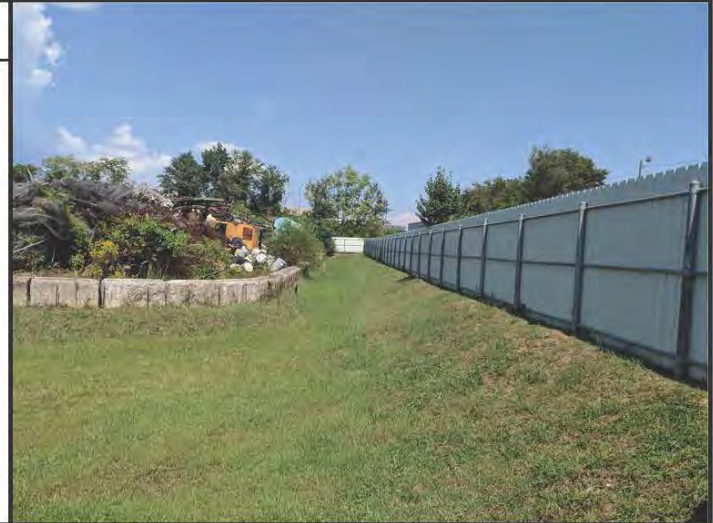
Photo No. 6	Date: 9/19/18
Description: View of bio-swale

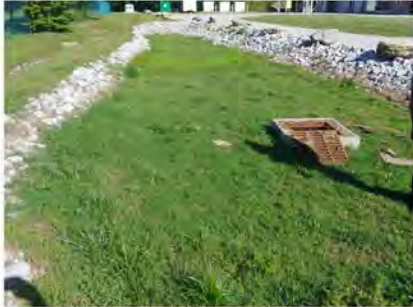
BEFORE MAINTENANCE: Bioretention Pond is full of old grass clippings.

AFTER MAINTENANCE: clippings

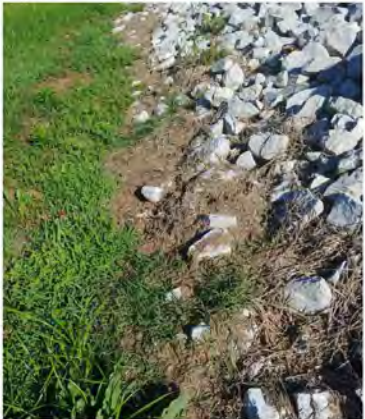
BEFORE MAINTENANCE: Bioretention Pond is full of old grass clippings. Grass clippings have accumulated and clogged the base of the filter dam.

AFTER MAINTENANCE: remove

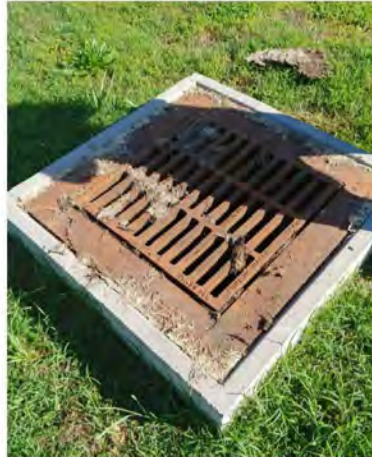
BEFORE MAINTENANCE: Bioretention Pond overflow structure grate has accumulated grass clippings, clogging grate openings.

AFTER MAINTENANCE

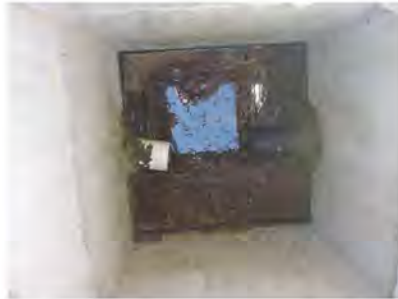
BEFORE MAINTENANCE: Overflow structure basin has sediment and debris (grass clipping) built up in the bottom.

AFTER MAINTENANCE: sediment and of the ov

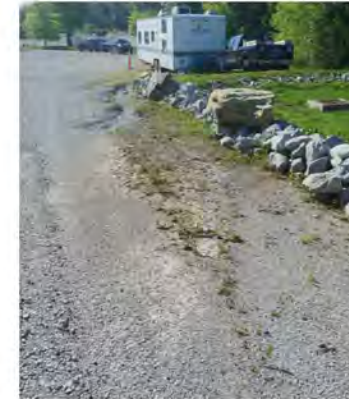
BEFORE MAINTENANCE: Gravel has washed out at the base of the rip rap filter dam. Sediment and weeds have accumulated and need to be removed.

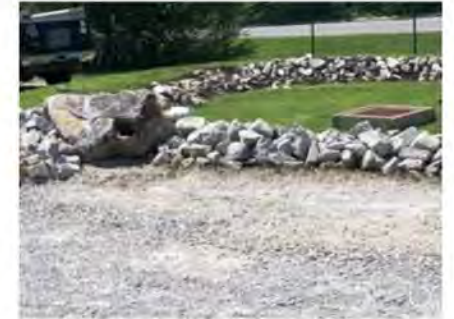
AFTER MAINTENANCE: Removed silt and weeds from washed out area. Replaced gravel, built up the eroded area, and added check dams.

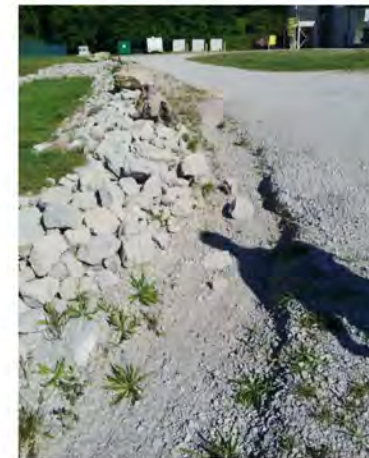
BEFORE MAINTENANCE: Gravel has washed out at the base of the rip rap filter dam.

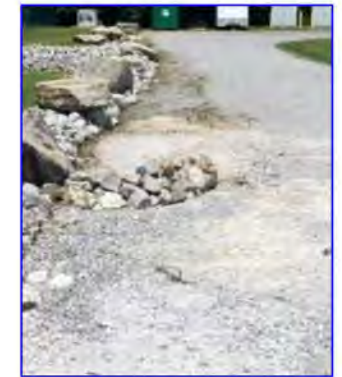
AFTER MAINTENANCE: Removed silt and weeds from washed out area. Replaced gravel, built up the eroded area, and added check dams.
